Mesa Verde National Park

Stabilization at 5MV3559, 5MV3543, 5MV3564

**Preservation Maintenance Assessment at 5MV542, 5MV544,
5MV548**

Field Season 2000

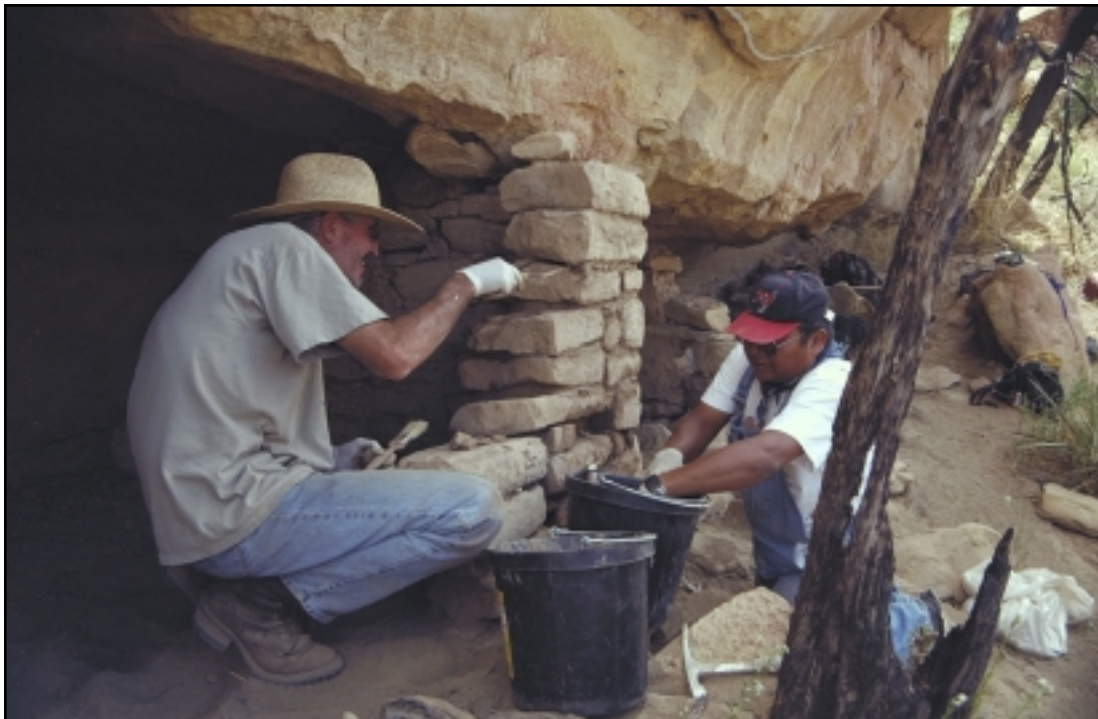
Figure 2.1. Neill Smith and Harold Peshlakai repointing a wall at site 5MV3559.

Repointing refers to the technique of applying a soil mortar over a like mortar; the joints are moistened with water to make the mortar stick. The character of the final joint extension and chinking is matched as closely as possible to the aboriginal mortar (Figure 2.1).

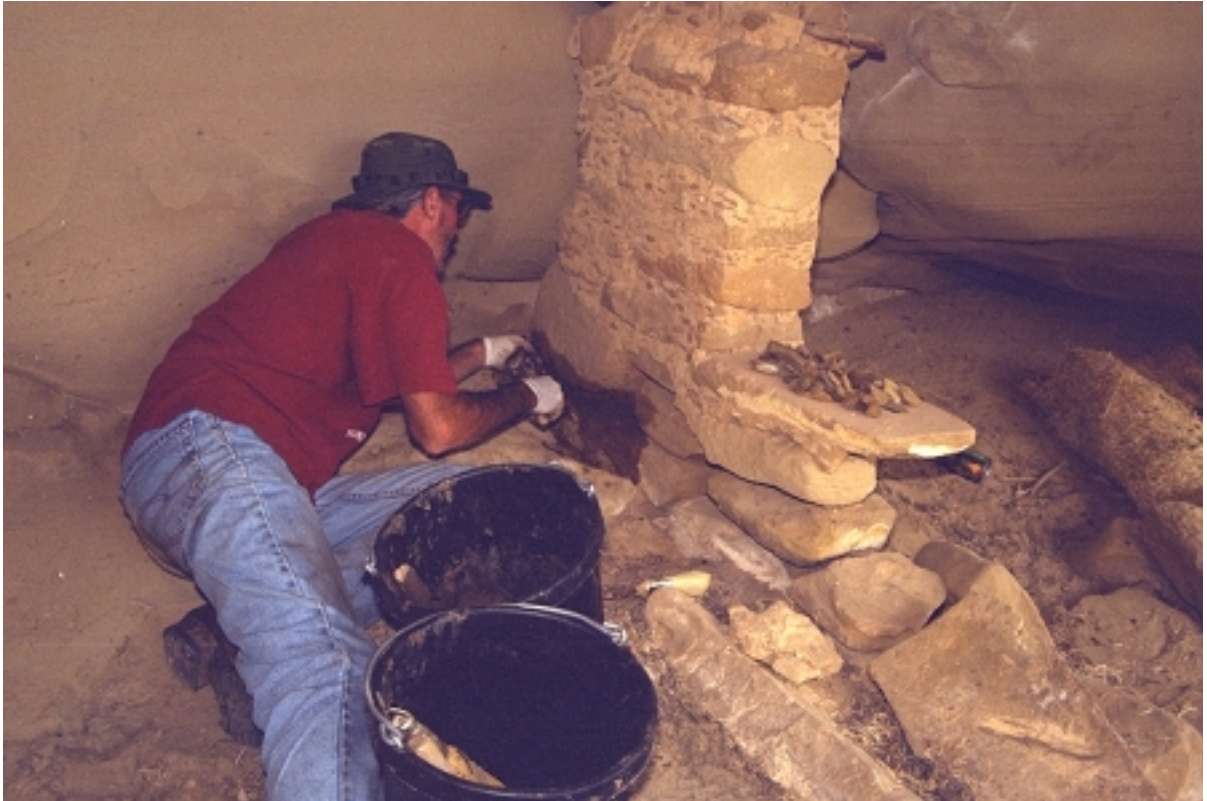
Figure 5.4. Neill Smith repointing the exterior east wall of Room 1.

Treatment took place from August 28 through 31, 2000. Both Neill Smith and Noreen Fritz treated this site (Figure 5.4). The bottom two basal courses of the

east wall of Room 1 were repointed. Two voids were filled with three stones and a void on the east exterior was filled with a replaced stone (Figure 5.5) (Figure 5.6). In addition, Fritz was responsible for photo and mapping documentation, and completion of the forms.
